TECHNICAL INFORMATION
BULLETIN/SAFETY ALERT DOC NO: _
TBSA-25-06

ITEM OF EQUIPMENT:	3306/3304 scrubber insert
VENTICO PART NUMBER:	153042, 704798
EARSA NUMBER:	3653

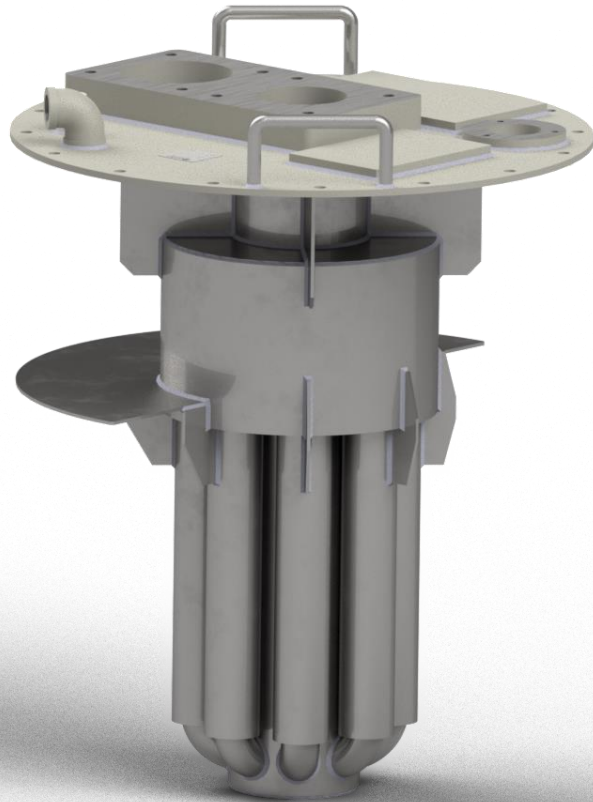
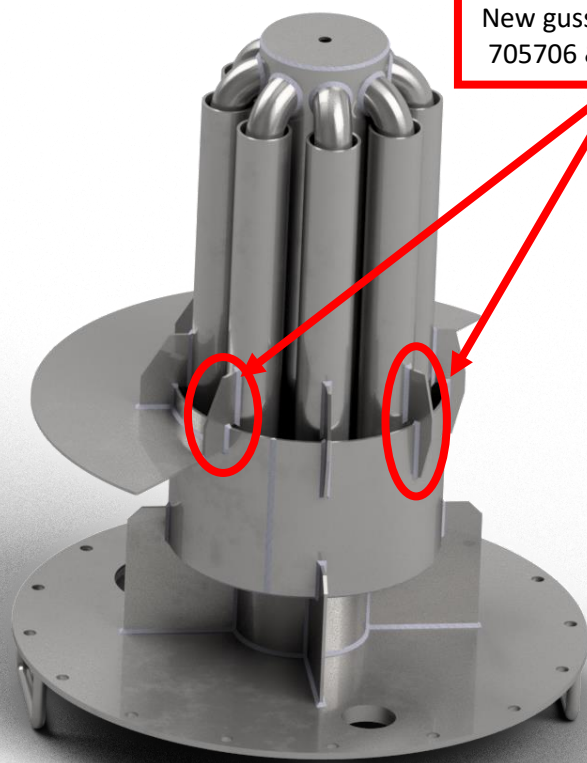
New gussets for upgraded design
705706 & 705707

Distribution:
All owners/operators of Ventico 3306/3304 DES systems
Action:
Additional stiffening gussets have been added to the scrubber insert to increase the rigidity and increase the strength. The Ventico scrubber insert should be returned to Ventico to have the upgrade fitted at the next maintenance interval or when possible. If a scrubber insert fails in this manner it must be repaired by replacement. See models showing upgrade using 5 short type gussets (705706) and 3 long type gussets (705707)
Issue:
A scrubber insert for the Ventico 3306/3304 DES was reported cracked - Investigation found that the parent metal of the center pipework, that transmits gas from the inlet to the bottom cauliflower(at the bottom of the scrubber), where a crack propagated from the toe of the weld where the skirt meets the center pipe. High gas temps were seen at the outlet of the scrubber causing SEMS to shut the machine down this shut down indicates a failure of the scrubber insert and should be inspected as soon as possible. This failure is unprecedented.

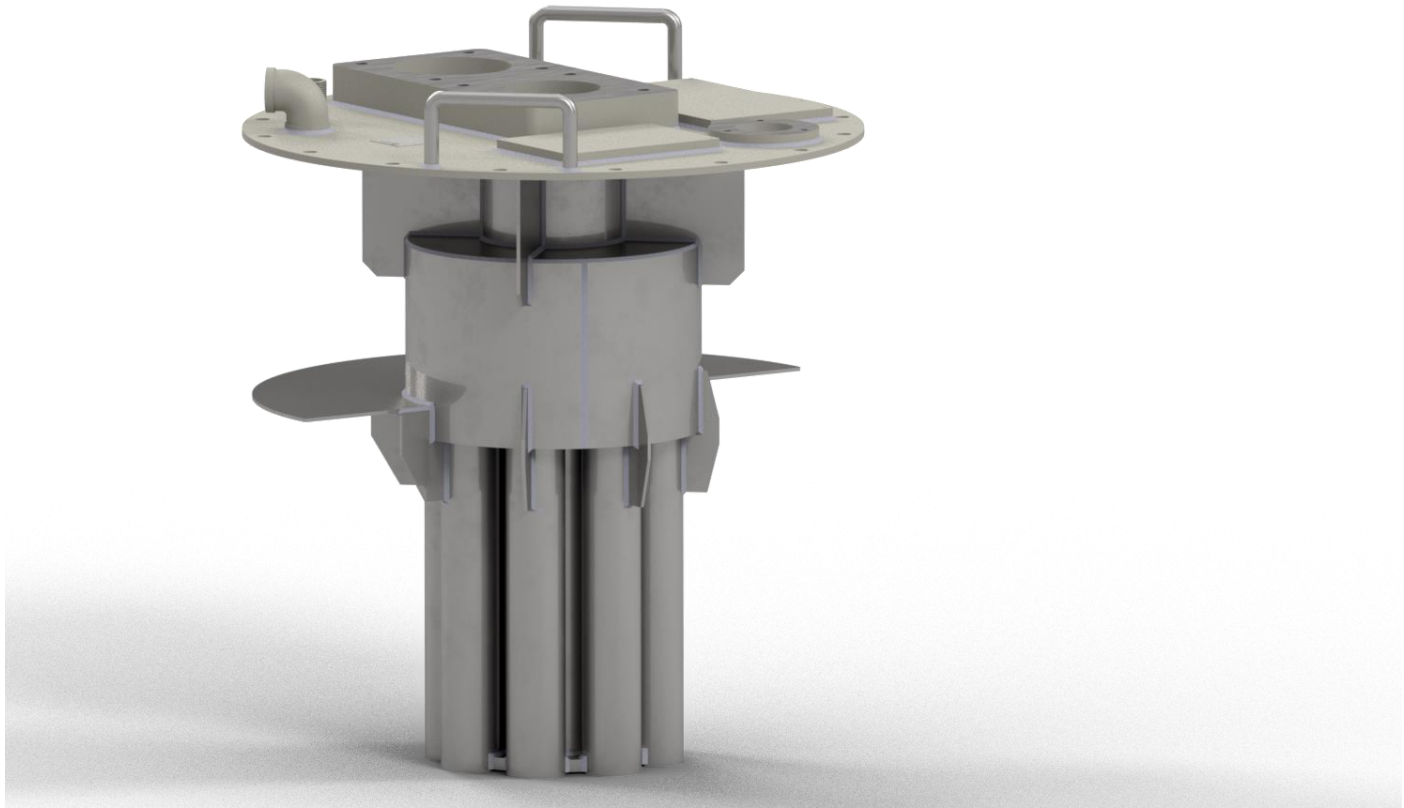
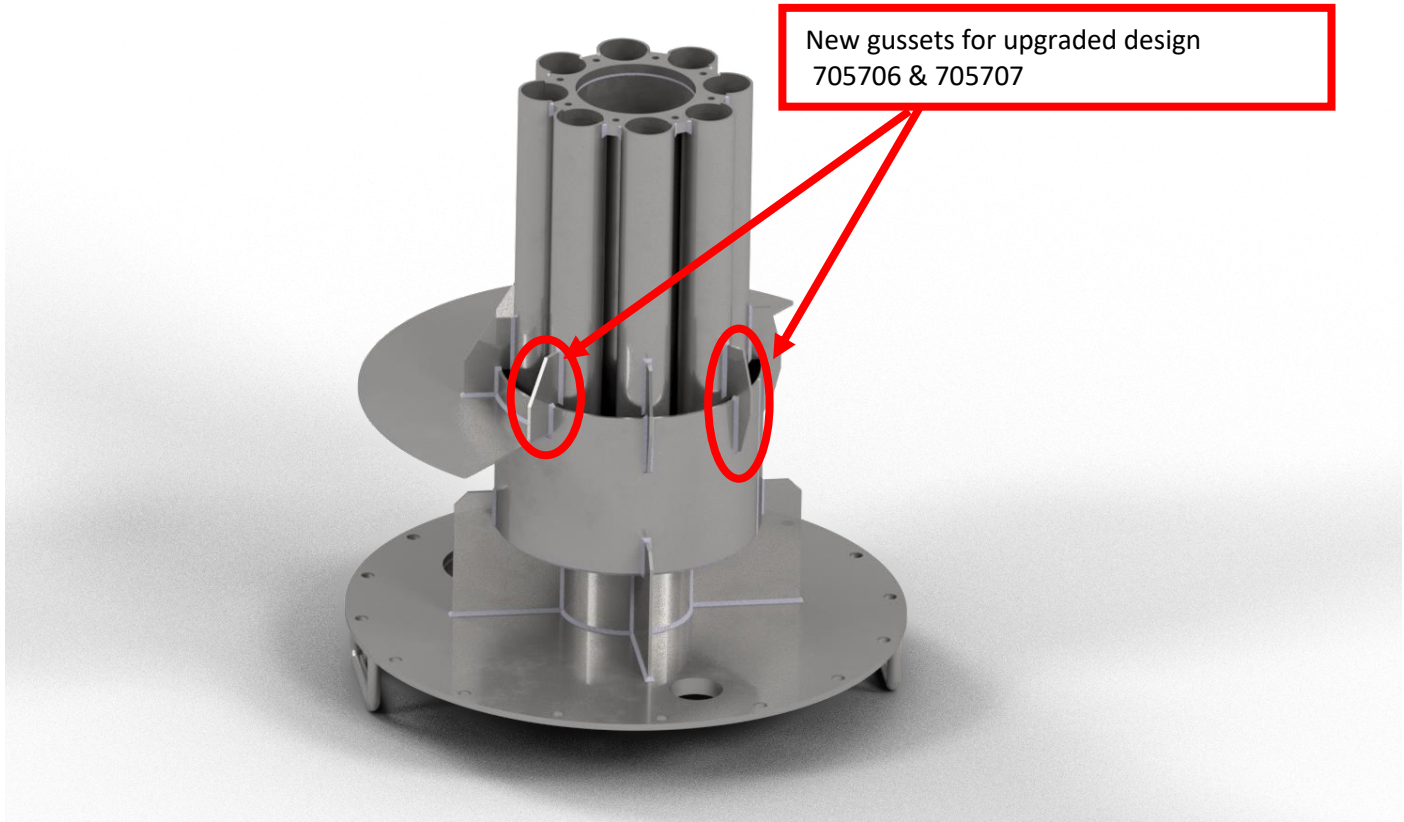
New gussets for upgraded design
705706 & 705707

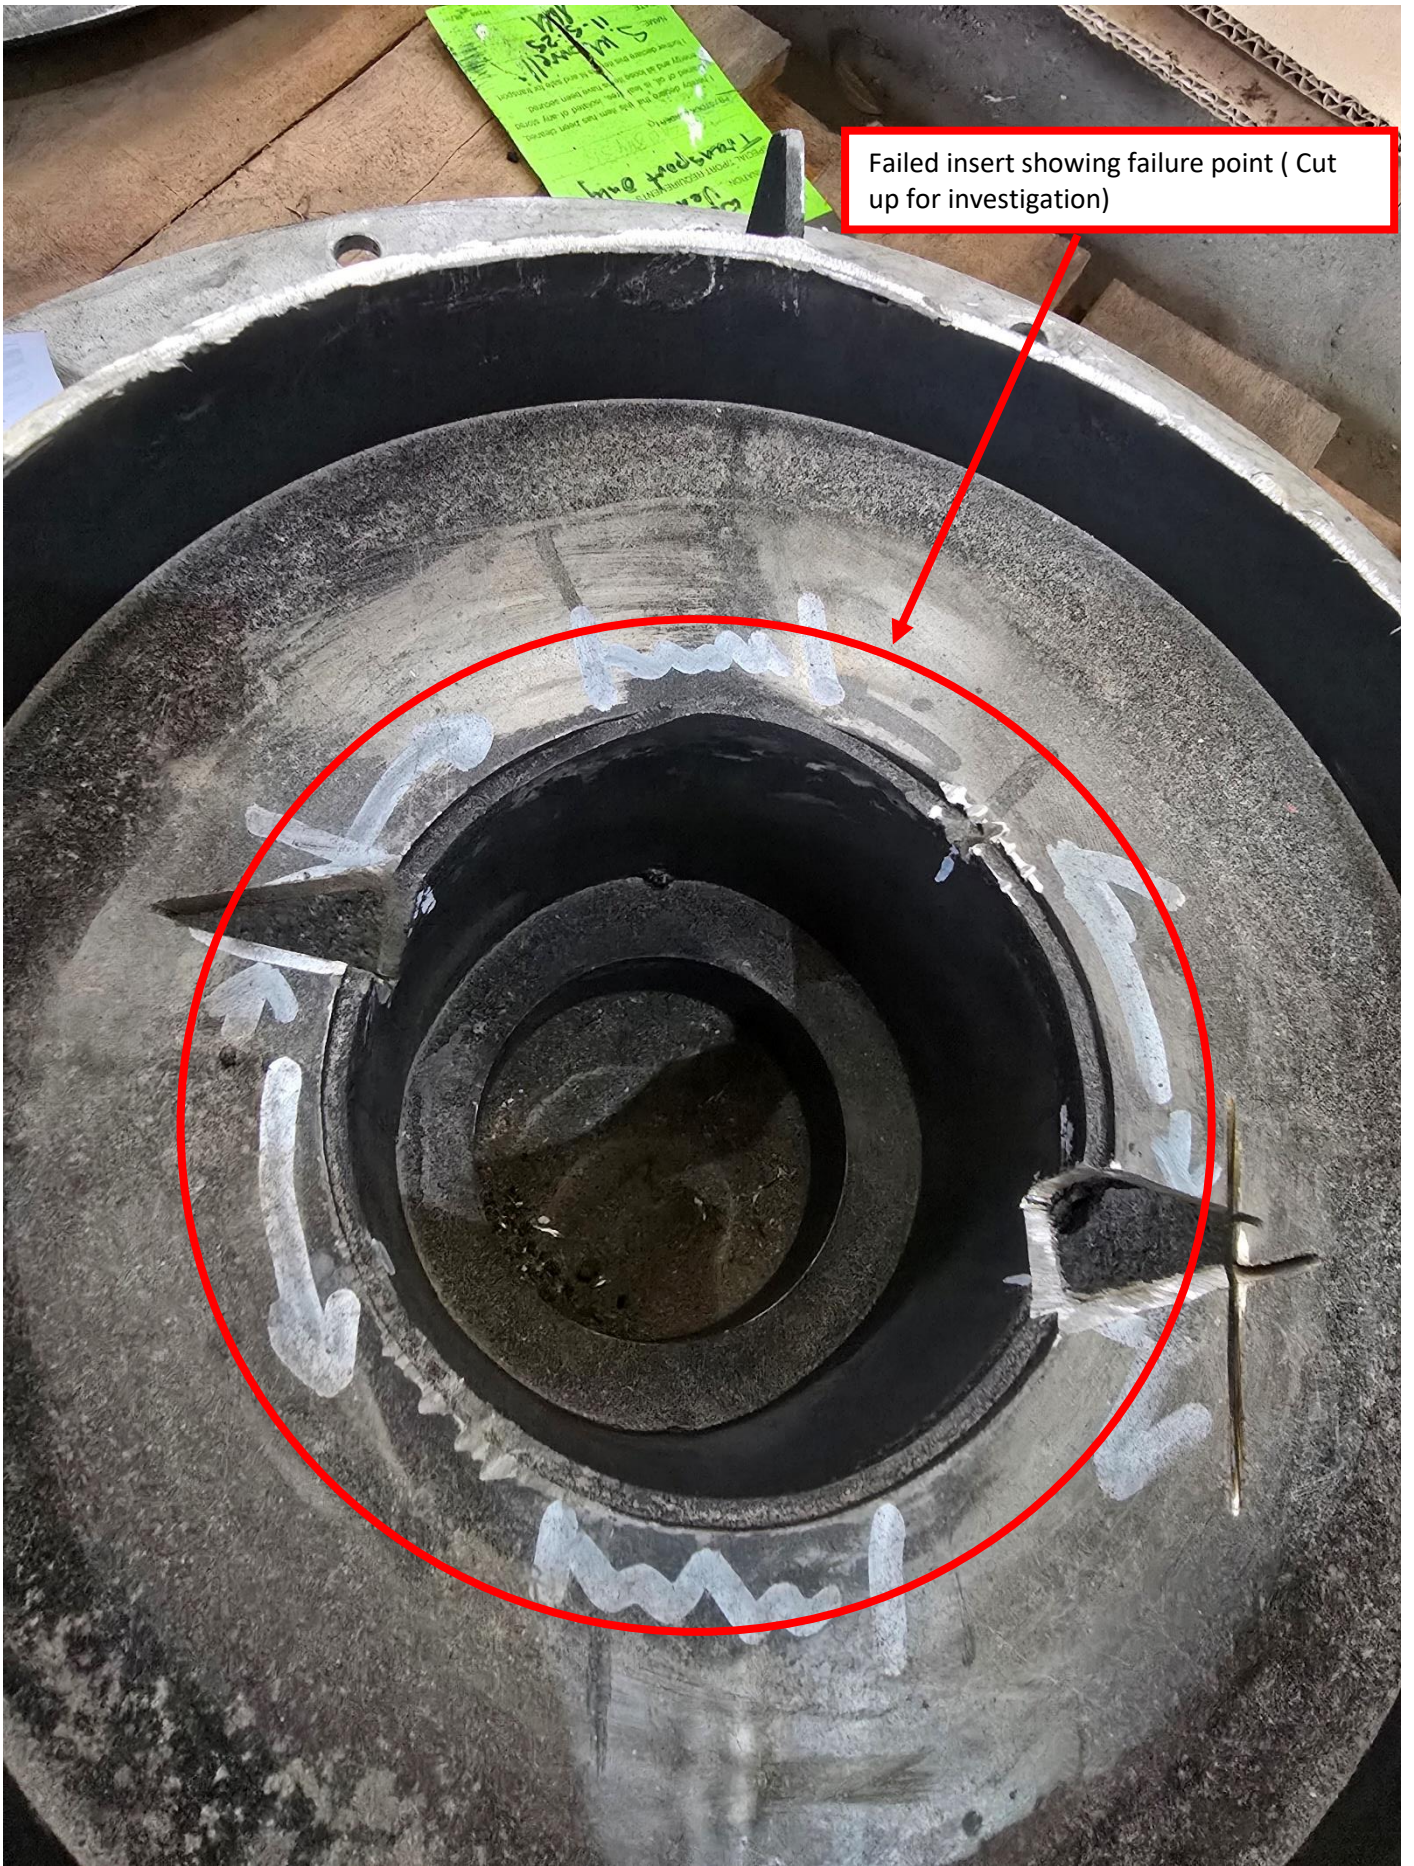
Failed insert showing failure point (Cut up for investigation)
